REVEGETATION AND SELECTED TERRAIN DISTURBANCES ALONG  
THE TRANS-ALASKA PIPELINE 1975-1978(U) COLD REGIONS  
RESEARCH AND ENGINEERING LAB HANOVER NH L A JOHNSON  
JUN 81 CRREL-81-12 F/G 6/6

## *Revegetation and selected terrain disturbances along the trans-Alaska pipeline, 1975-1978*

Lawrence A. Johnson

June 1981

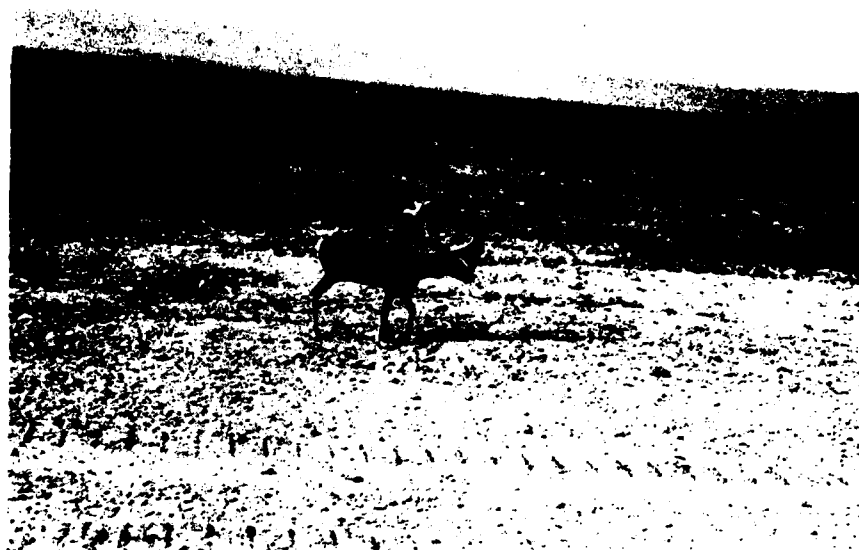
Figure 15. Caribou grazing on revegetated workpad, 14 August 1978.

13. *Animal grazing.* Various populations of native mammals and birds have been observed grazing upon revegetated areas. They included microtines at numerous locations, caribou north of Toolik (Fig. 15) and especially at site 127J1, dall sheep along the workpad near Galbraith Camp, bison at AS 42 and moose in the Interior (Fig. 16). Birds such as ptarmigan and migratory waterfowl extensively grazed on revegetated areas north of Toolik. Presumably these animals were attracted by factors such as the delayed senescence of introduced species and the higher nutrient content of vegetation within the fertilized areas.

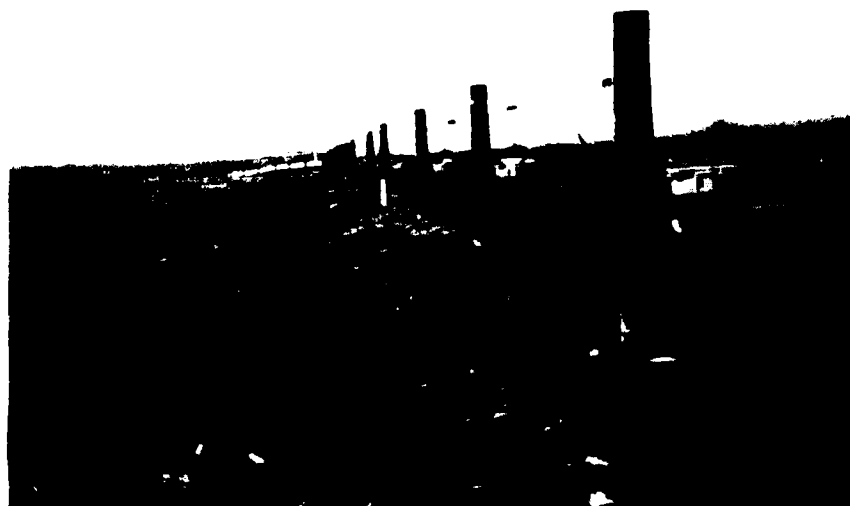
Generally, there was much less debris than along the fuel gas line (Fig. 54). However, there did seem to be much greater damage to tussocks with some exposure of organic and mineral soil along the oil pipeline snowpad (Fig. 55). Once again, moss and upright shrubs sustained a disproportionate amount of damage, although shrubs had largely recovered by 1978. The percentage cover of mosses was reduced in both 1976 and 1978, whereas vascular plant cover was not affected (Table 8). Much of the herbaceous regrowth was from grasses, primarily *Arctagrostis latifolia* (Fig. 56). *A. latifolia* also produced numerous seed heads during 1978 in the area of the traffic lane of the snowpad (Fig. 57). This increased seed production may have been caused by the greater depth of thaw associated with the traffic lane rather than the snowpad itself. Little increase in flowering was observed near the VSM's.

*Figure 54. Area that lay beneath oil pipeline snowpad, 19 August 1976.*

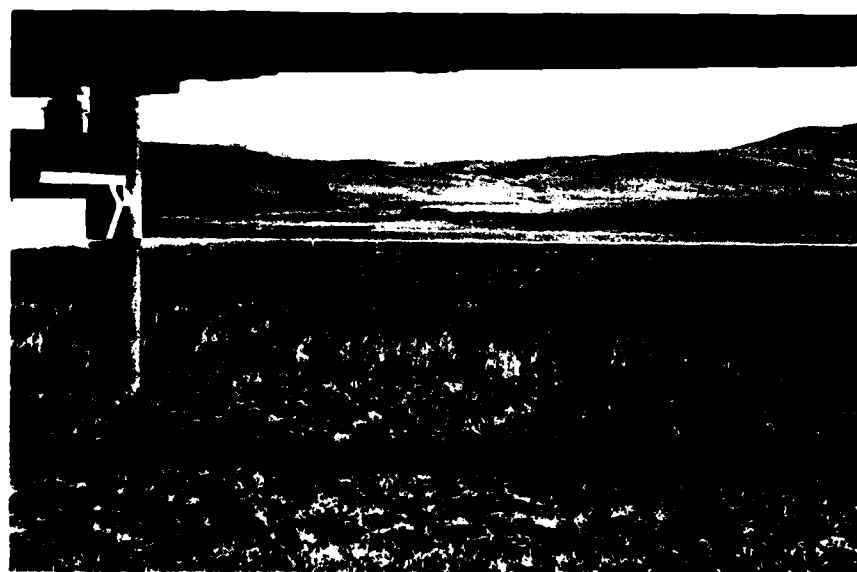
Figure 57. View across oil pipeline snowpad towards gas feeder line and road, 14 August 1978. Abundant seed heads of *Arctagrostis latifolia* can be seen where the traffic lane was on the snowpad (middle of photo).

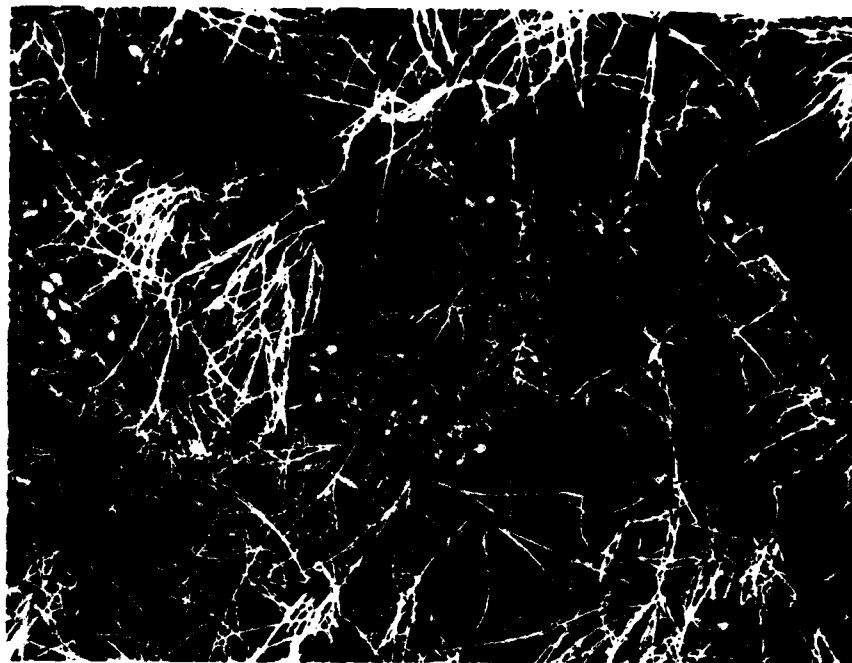
At 20 m from the valve, the oil saturated the litter layer but had only penetrated the organic layer 1 to 2 cm. At 60 m, there was 50% live cover despite a 90% cover of oil on the ground-surface (Fig. 62). Finally at 160-m distance, there

*Figure 62. Regrowth of shrubs and monocots, 60 m downwind from valve 7, 12 August 1978.*

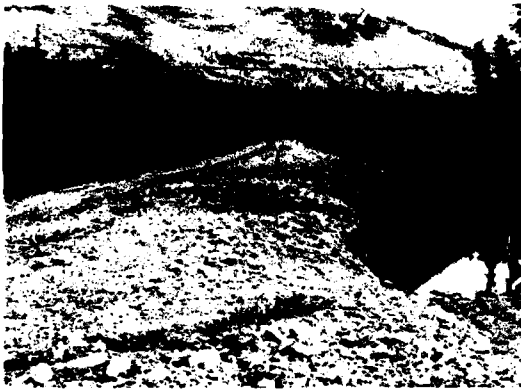
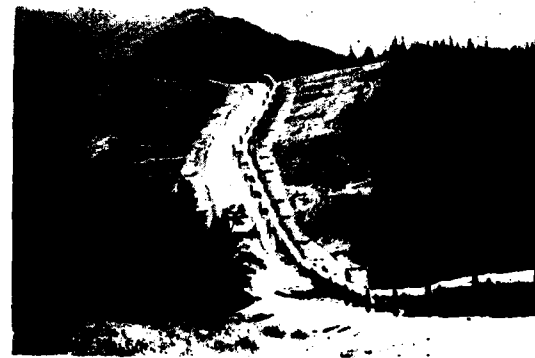
Figure B5. Site 16J1, Squirrel Creek slope. Steep north-facing slope with erosion gullies (1975), north-facing slopes terraced and stable with good vegetation cover (1976), vegetative cover reduced though still adequate on north-facing slopes, but severe erosion on south-facing slope (1977), site largely stable (1978). Native species include lamb's-quarters and squirreltail.

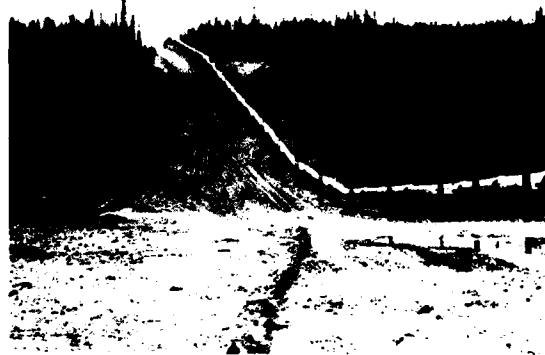
c. June 1977 (—, 30, —).

a. September 1976 (—, 60, —) seeded.

d. September 1978 (—, 10, 60) fescue, annual rye.

Figure B10. Site 21J1, slope beside Pump Station 11. Area partially regraded in 1976 after massive slope failure in 1975, limited revegetation by 1978. Native species: strawberry blight, balsam poplar and a weedy grass (*Bromus tectorum*).

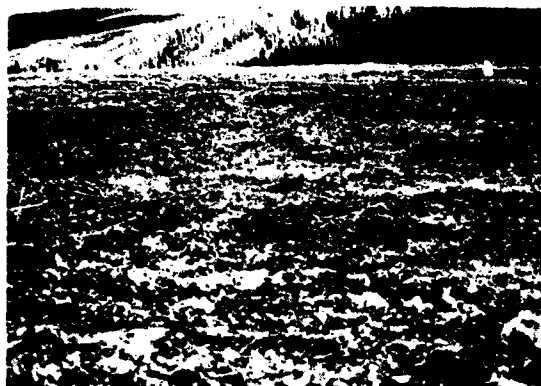
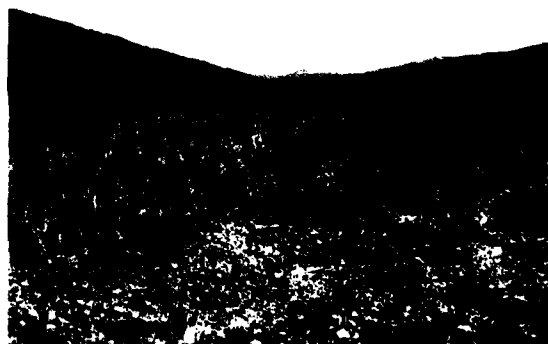
a. May 1976, seeded over organic and fine-grained disposal materials in site.

b. June 1977 (—, 70, 140) timothy, bluegrass.

c. August 1978 (10, 40, 100) foxtail, annual rye.

Figure B22. Site 71J1, material site. Seeded (1976), lower portions of large material site on hilltop regraded (1977), most of site revegetated but patchy vegetative cover (1978). Native species: fireweed and squirreltail.

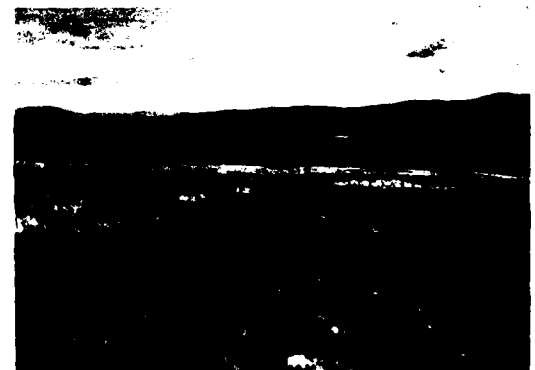
Figure B24. Site 73J2, July 1975, seeded, annual rye. Material site, mile 19.3. Lower portion hydroseeded (1975), site re-excavated (1976).

b. June 1976 (100, 20, 15) annual rye, foxtail, brome.

Figure B25. Site 77J1, disposal site 77-48. Aerial seeding produced lush growth of annual rye. Some areas of coarse gravel shoulder were sparsely seeded using wood fiber mulch (1975). Cover reduced, heavy litter cover, equipment ran over some seeded areas (1976), cover still reduced (1977), adequate cover with moss cover 30% (1978). Native species: squirreltail, fireweed, and many willow seedlings (1978).

c. July 1977 (\_\_, 60, \_\_) timothy, fescue, bluegrass.

a. July 1975 (\_\_, \_\_, \_\_) seeded.

d. August 1978 (80, 50, 117) fescue, foxtail.

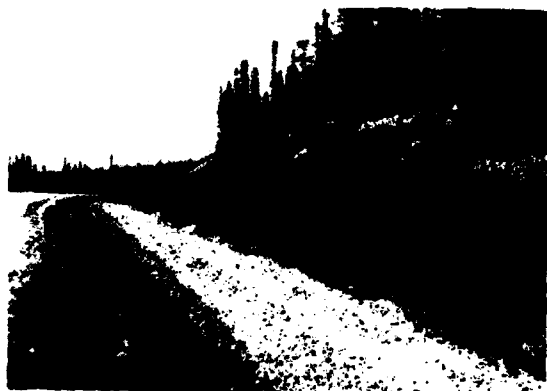
Figure B28. Site 80J1, road cut. Germination low on upper slope, willows reinvading (1976), some slumping (1976), most of slope revegetated (1978). Native species: willow, rock harlequin, horsetails, fireweed, prickly rose and squirreltail.

a. September 1975, seeded.

b. July 1977 (50, 70, 100) foxtail, fescue, bluegrass.

b. September 1976 [10, (100-lower, 10-upper), 120] seeded, foxtail, annual rye.

c. July 1977 (—, 80, 160) foxtail, bluegrass, fescue.

d. August 1978 (—, 80, 152) foxtail, brome, bluegrass.

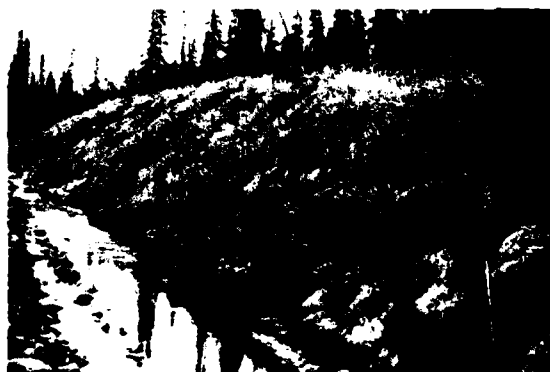
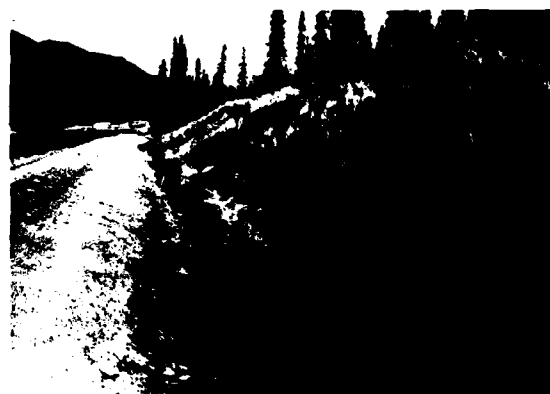
Figure B46. Site 107J1, road cut of fine-grained silts. Trees cut on vegetative mat to allow slumping over road cut (1975), bank stable with good vegetative cover (1977). Native species: squirrel-tail, lamb's-quarters, bluejoint reedgrass.

a. September 1975 (—, 90, —) seeded.

b. July 1977 (—, 40, 80) reseeded, annual rye.

c. August 1978 (60, 50, 111) foxtail, fescue, bluegrass.

d. August 1978 (90, 80, 81), foxtail, fescue.

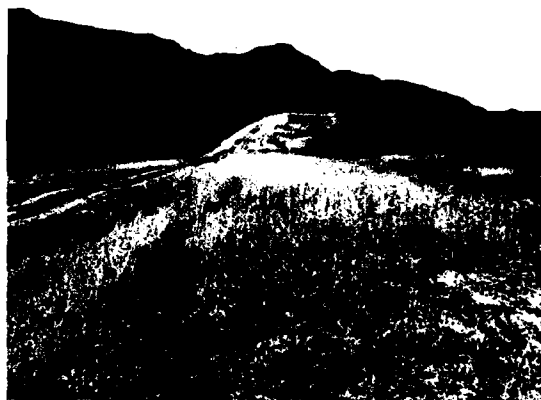
Figure B50. Site 109J1, August 1978 (\_\_, 60, 87) foxtail, timothy, bluegrass. Reseeded workpad with willow cuttings (1977), good growth of grasses, no cutting survival (1978).

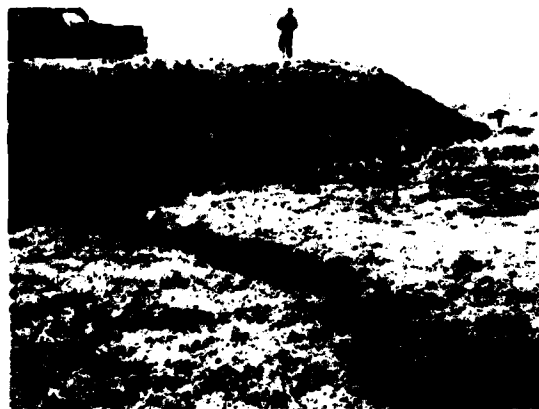
a. August 1976 (—, 60, 150—test plot; —, 10, 3—uncleared), seeded.

b. July 1977 (—, 80, 50; —, 60, 15).

c. August 1978 (30, 80, 75; 50, 80, 35), tall arctic-grass on test plot.
